Flood Control Project Maintenance
2011 Structure Summary Report
Overall Unit and Item Ratings

City of Sacramento

Flood Control Project Maintenance**Unit Cover Sheet****2011 Structure Inspection Results****City of Sacramento**

Levee Inspection Report By Mile - Structure 2011

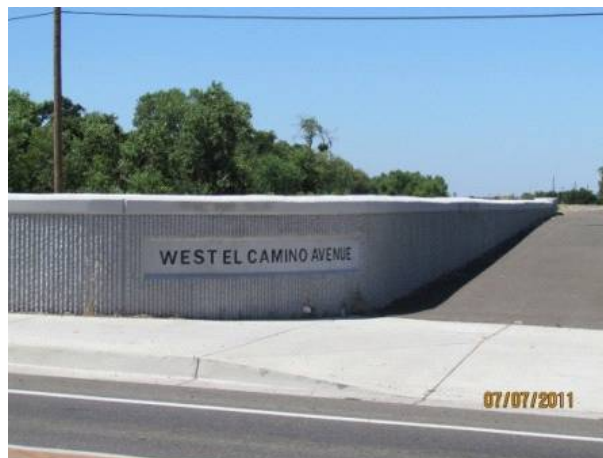
Levee Mile Report Line	1
Start Levee Mile	0.00
End Levee Mile	0.00
Location	
Category	Structures
Item	Photo Documentation

View of the flood wall.

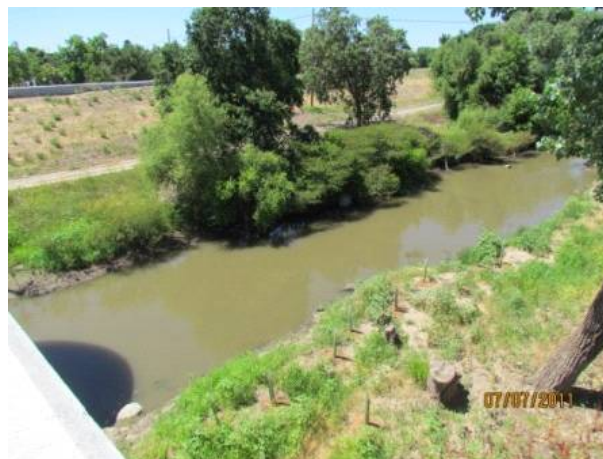
Levee Mile Report Line	2
Start Levee Mile	0.00
End Levee Mile	0.00
Location	
Category	Structures
Item	Vegetation & Obstructions

View of the channel under the bridge.

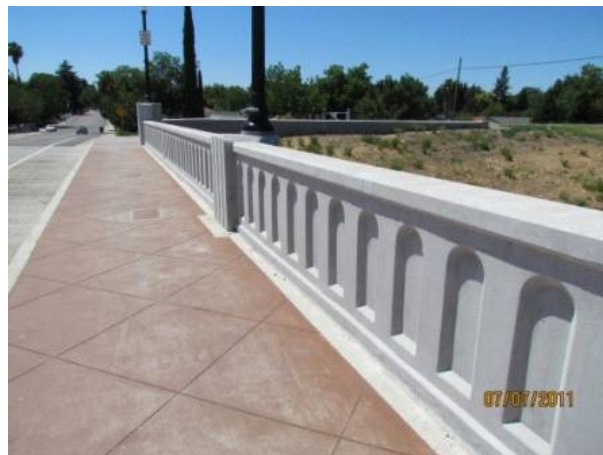
Levee Mile Report Line	15
Start Levee Mile	0.00
End Levee Mile	0.00
Location	
Category	Structures
Item	Concrete Surfaces

View of the flood wall.

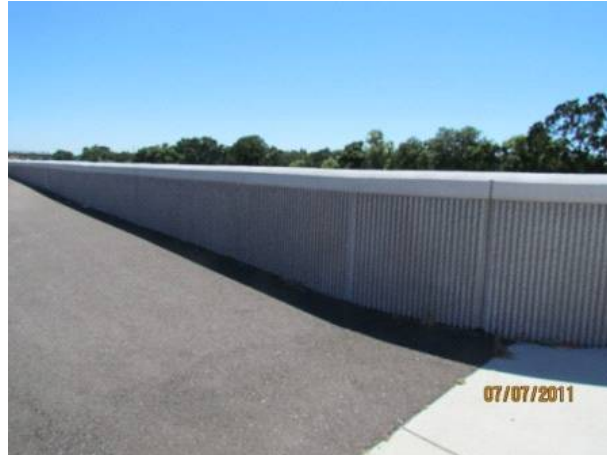
Levee Mile Report Line	22
Start Levee Mile	0.00
End Levee Mile	0.00
Location	
Category	Structures
Item	Monolith Joints

View of the flood walls with monolith joints.

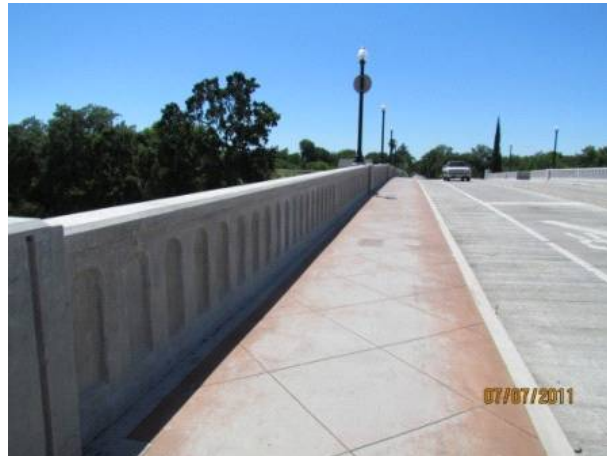
Levee Mile Report Line	22
Start Levee Mile	0.00
End Levee Mile	0.00
Location	
Category	Structures
Item	Monolith Joints

View of flood walls with monolith joints.

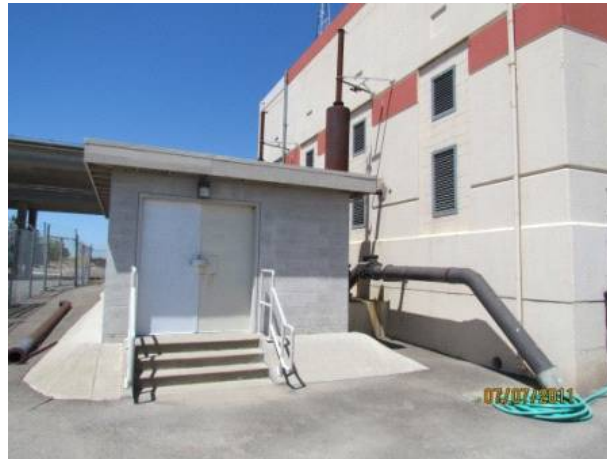
Levee Mile Report Line	3
Start Levee Mile	0.00
End Levee Mile	0.00
Location	
Category	Pump Stations
Item	Plant Building

View of the control room next to the pumping plant.

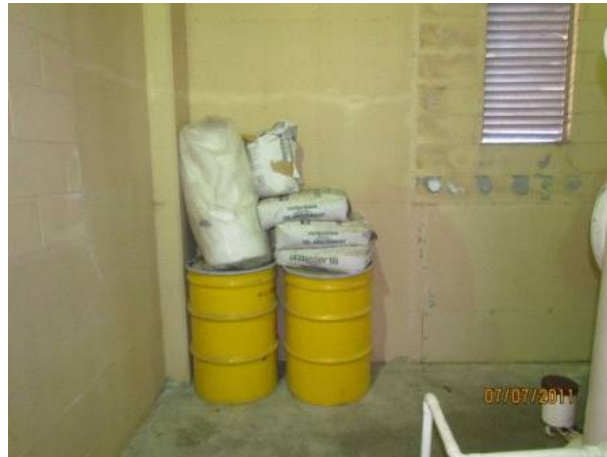
Levee Mile Report Line	5
Start Levee Mile	0.00
End Levee Mile	0.00
Location	
Category	Pump Stations
Item	Safety

Safety material for oil spills was present inside the structure.

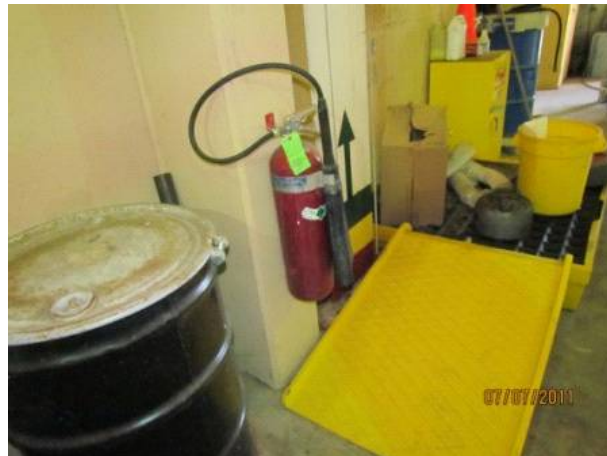
Levee Mile Report Line	5
Start Levee Mile	0.00
End Levee Mile	0.00
Location	
Category	Pump Stations
Item	Safety

Fire extinguisher inside the pumping plant.

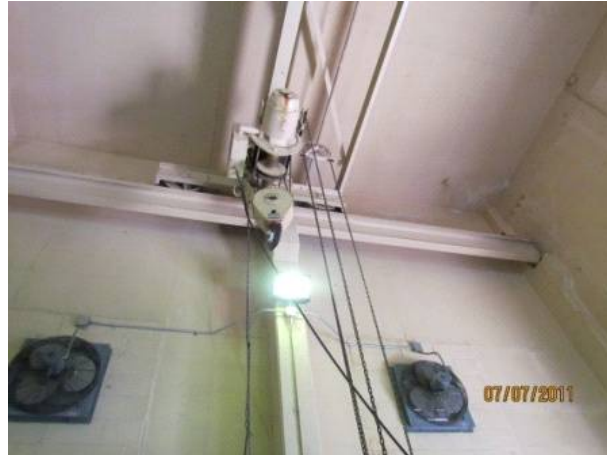
Levee Mile Report Line	6
Start Levee Mile	0.00
End Levee Mile	0.00
Location	
Category	Pump Stations
Item	Cranes

View of the crane at the pumping plant.

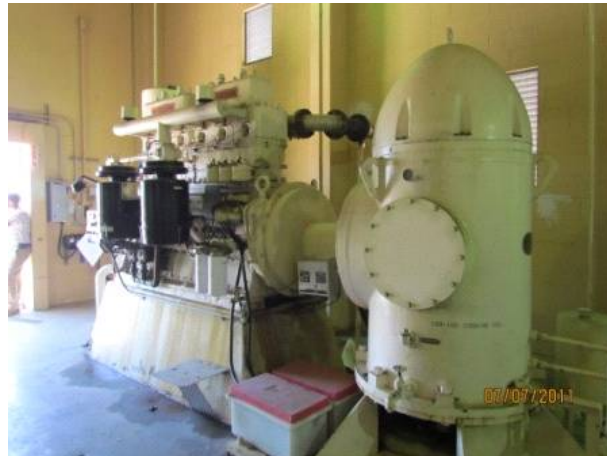
Levee Mile Report Line	7
Start Levee Mile	0.00
End Levee Mile	0.00
Location	
Category	Pump Stations
Item	Pumps

View of one of the pumps.

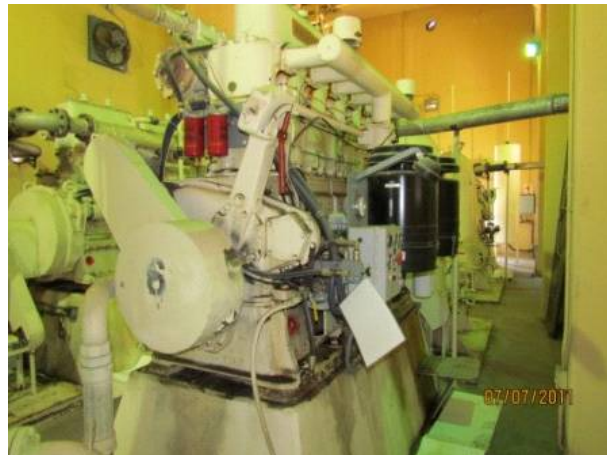
Levee Mile Report Line	7
Start Levee Mile	0.00
End Levee Mile	0.00
Location	
Category	Pump Stations
Item	Pumps

View of one of the pumps inside the pumping plant.

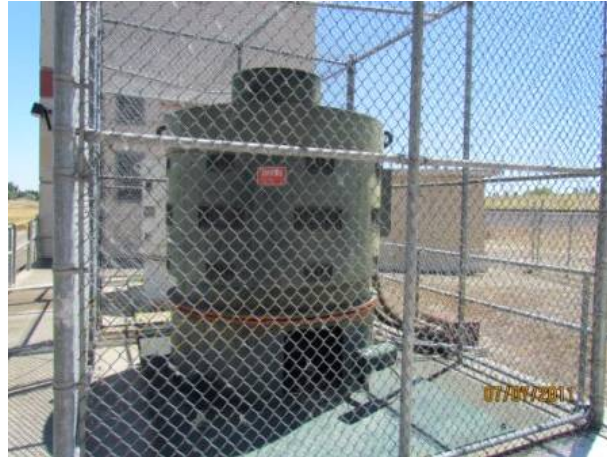
Levee Mile Report Line	7
Start Levee Mile	0.00
End Levee Mile	0.00
Location	
Category	Pump Stations
Item	Pumps

View of one of the pumps outside of the building.

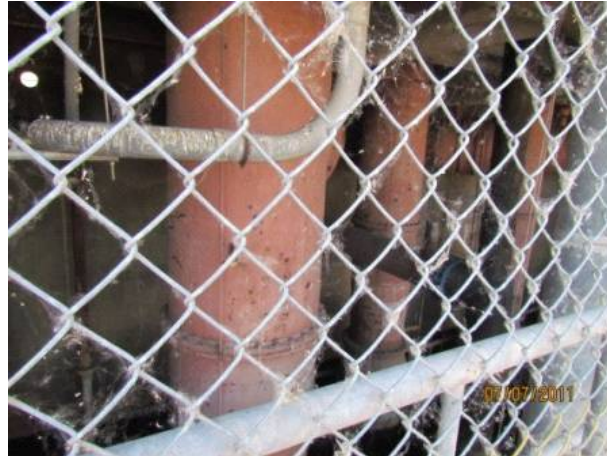
Levee Mile Report Line	11
Start Levee Mile	0.00
End Levee Mile	0.00
Location	
Category	Pump Stations
Item	Sumps/Wet Well

View of the wet well below the pumping plant.

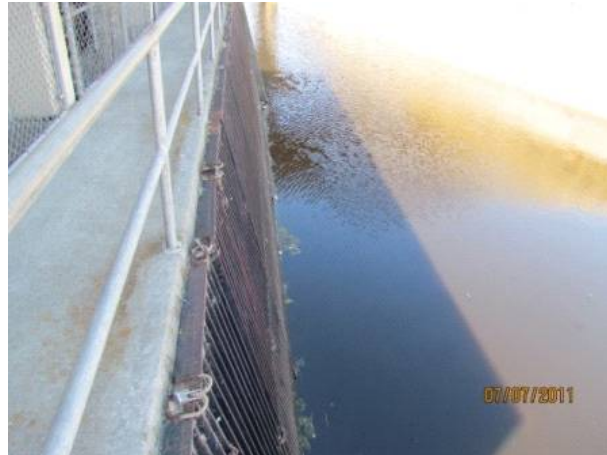
Levee Mile Report Line	12
Start Levee Mile	0.00
End Levee Mile	0.00
Location	
Category	Pump Stations
Item	Trash Racks

View of the trash rack.

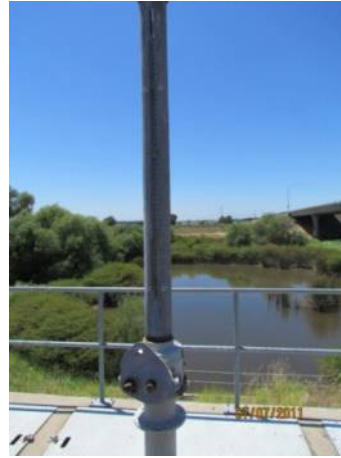
Levee Mile Report Line	15
Start Levee Mile	0.00
End Levee Mile	0.00
Location	
Category	Pump Stations
Item	Manual Gate Operators

View of the slide gate operator.

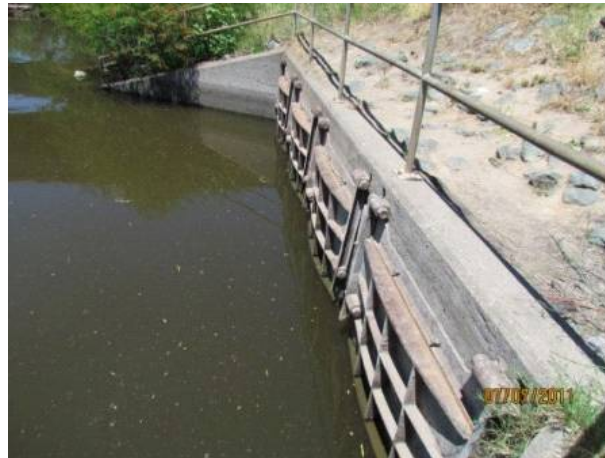
Levee Mile Report Line	17
Start Levee Mile	0.00
End Levee Mile	0.00
Location	
Category	Pump Stations
Item	Flap Gates

View of the flap gates.

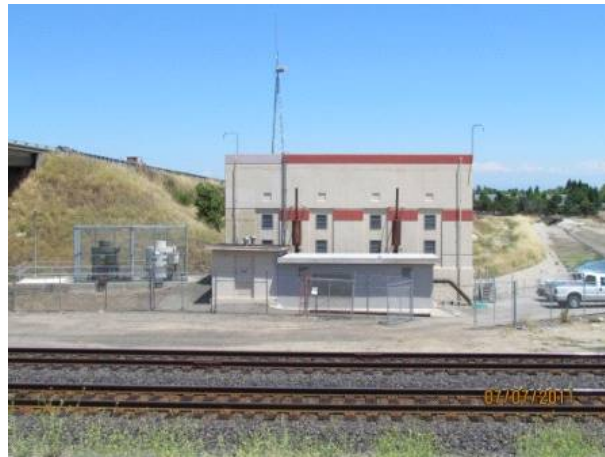
Levee Mile Report Line	19
Start Levee Mile	0.00
End Levee Mile	0.00
Location	
Category	Pump Stations
Item	Security Fencing

View of the security fencing around the structure.

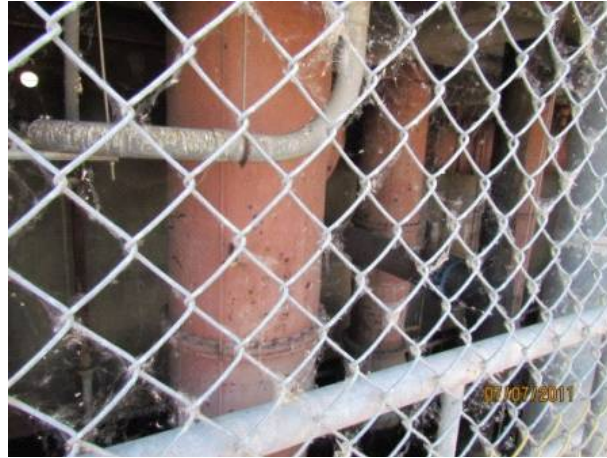
Levee Mile Report Line	20
Start Levee Mile	0.00
End Levee Mile	0.00
Location	
Category	Pump Stations
Item	Intake and Discharge Pipes

View of the intake pipes.
